**FLY-ASH BASES IN THE ATLANTA DISTRICT:
EVALUATION OF SURFACE TREATMENT BOND
AND
YEAR-TWO FIELD PERFORMANCE EVALUATIONS**

Cindy Estakhri
Assistant Research Engineer
Texas Transportation Institute

Report 2966-2
Project Number 7-2966
Research Project:
Durability of Surface Treatments as the Wearing Course
Placed on Crushed Fly Ash and Long-Term Performance
of Crushed Fly Ash for Flexible Base

December 1998

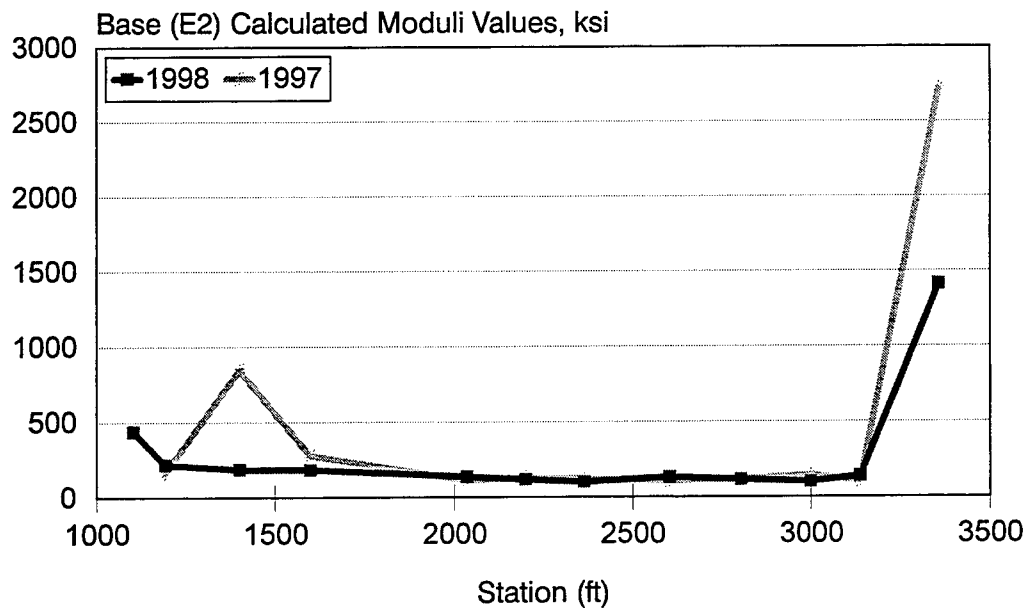
Figure 8. Base Moduli Values for IH 20 Frontage Road

Three cores were obtained from this pavement as shown in Figure 6. Last year, this pavement exhibited the highest compressive strength but there was a loss in strength as noted with the cores taken in 1998. However, there doesn't seem to be an appreciable difference in the base moduli values from 1997 to 1998 (Figure 8). Note in Figure 8, that the last data point may coincide with the beginning of a different type of pavement section.

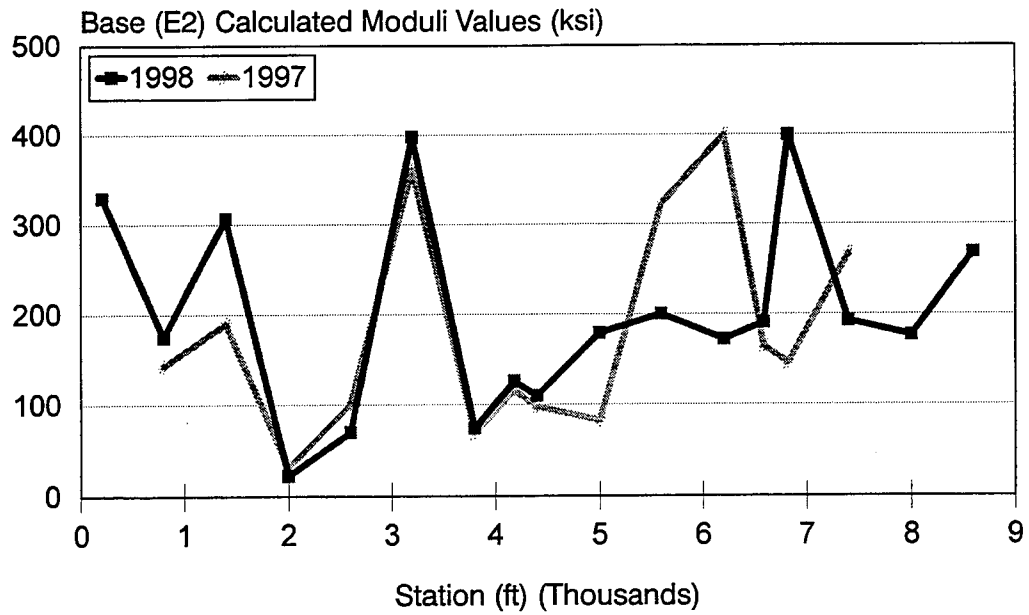
Figure 11. Base Moduli Values for FM 1520

Three cores were obtained from FM 1520 and two of the three cores showed a significantly greater compressive strength than the previous year. FWD data (Figure 11) on this pavement indicates that there is no significant change between 1997 and 1998.

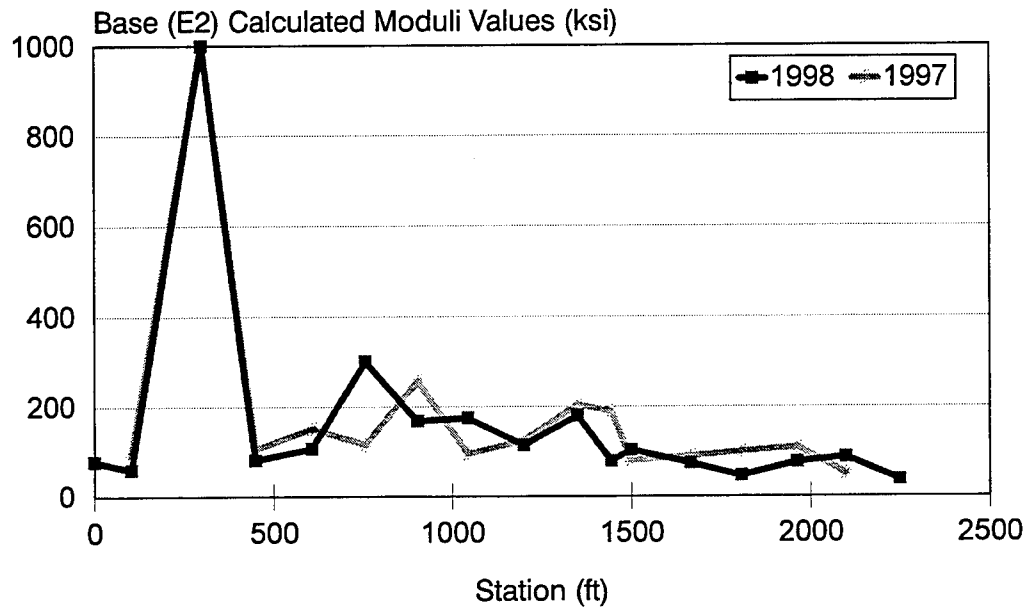
Figure 12. Base Moduli Values for FM 560.

All three cores obtained from FM 560 had a higher compressive strength than the cores obtained the previous year. The base on this pavement has two different thicknesses along its length: 9 inches and 16 inches. Because of the difference in thicknesses, two separate FWD analyses were performed as shown in Table 14. Results from both analyses, however, were combined for Figure 12. Moduli values for this pavement do not appear to be as variable as on some of the others; however, the values are lower than the desired minimum of 145,000 psi. Also, however, there seems to be little change in moduli values between 1997 and 1998.
